Petrographic Investigation of Concrete Cores Extracted from Aprons at the Billings Logan International Airport Located in Billings, Montana

Montana State University Bozeman, Montana

Prepared by Chunyu Qiao, Ph.D.

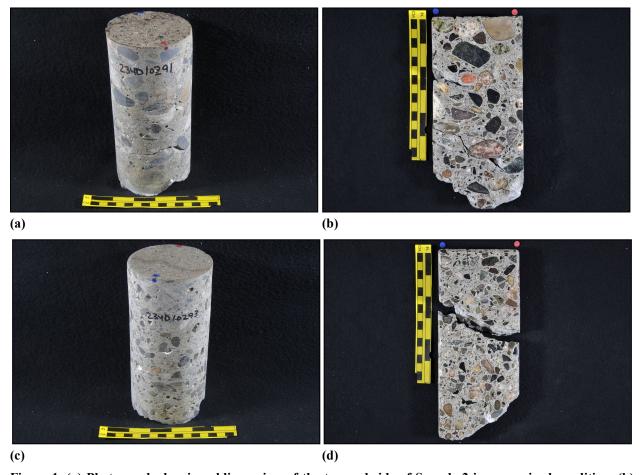
orientation, Dimensions & As-Received Condition The cores are vertical in orientation, measure ~ 95 mm (3 ¾ in.) in diameter and range from 160 - 205 mm (6 ¼ - 8 in.) in length. The cores are hard and compact. The top surface of each core shows significant wear such that the original texture is not apparent and the bottom surface of each core is a fracture such that the cores represent a partial thickness of the aprons. Both cores were received in two pieces with a sub-horizontal fracture in the middle of the cores. White deposits of ASR gel were observed on the fracture surface and the bottom surface of both cores. Figure 1 shows photographs of the cores in their as-received condition and the polished surface from each core. Figure 2 shows photomicrographs of the top surface of each core. Figure 3 shows photomicrographs of the white deposits on the fracture and bottom surface of each core.

Figure 1. (a) Photograph showing oblique view of the top and side of Sample 2 in as-received condition. (b) Photograph showing the polished surface of Sample 2. (c) Photograph showing oblique view of the top and side of Sample 5 in as-received condition. (d) Photograph showing the polished surface of Sample 5. The red and blue dots indicate the orientation of the saw cuts used to prepare the sample for petrography. The small and large divisions on the yellow scale are in centimeters and inches, respectively.

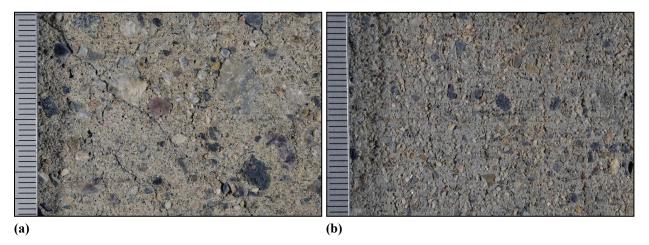
Figure 2. Photograph showing the top surface of (a) Sample 2 and (b) Sample 5, respectively, in as-received condition. The scale in both images is in millimeters.

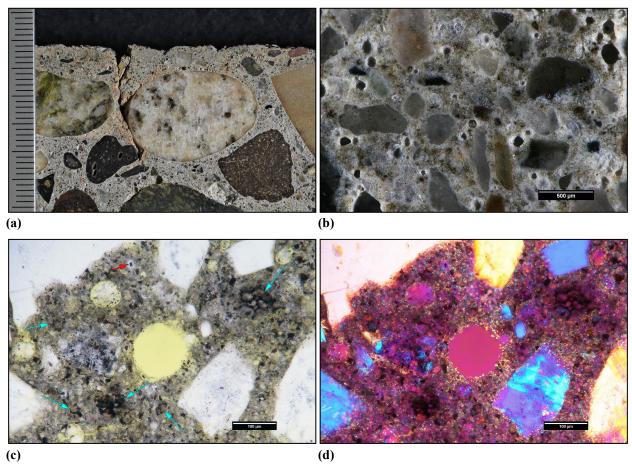
3.2 Components: Paste The paste in Sample 2 contains hydrated portland cement with no fly ash or other supplemental cementitious materials, while the paste in Sample 5 contains hydrated portland cement with fly ash. The hydration is normal in both cores. The capillary porosity of the paste is moderate and relatively consistent. The water-cementitious materials ratio (w/cm) of the paste was not estimated because of evidence of significant alteration of the paste by mechanisms such as ASR and ettringite mineralization. Both of these mechanisms require the ingress of moisture, which obscures the original w/cm. Figure 4 and Figure 5 show photomicrographs of the paste in Sample 2 and Sample 5, respectively. Figure 6 shows transmitted fluorescent light photomicrographs of thin sections that indicate the capillary porosity of the paste in each core.

Figure 4. Paste characteristics in Sample 2. (a) Photograph of the polished surface showing overview of the paste near the top surface; scale in millimeters. (b) Reflected light photomicrograph of the polished surface showing the detail of paste in the middle of the core. (c) Plane-polarized transmitted light photomicrograph of thin section showing detail of the paste. The red and light blue arrows indicate alite and belite, respectively. (d) Cross-polarized transmitted light photomicrograph of thin section with gypsum plate inserted showing detail of the paste.

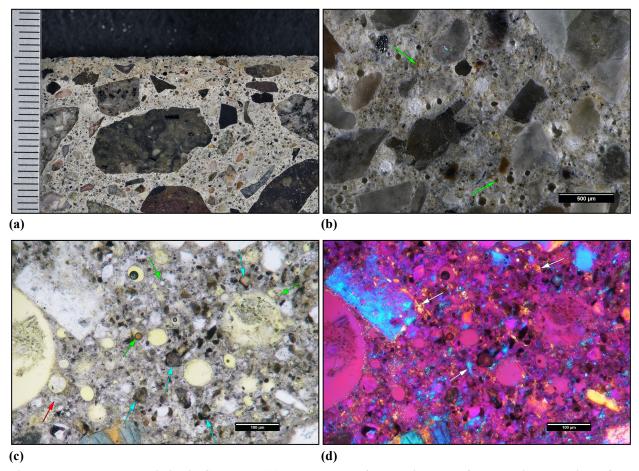
Figure 5. Paste characteristics in Sample 5. (a) Photograph of the polished surface showing overview of the paste near the top surface; scale in millimeters. (b) Reflected light photomicrograph of the polished surface showing the detail of paste in the middle of the core. The green arrows in (b) indicate fly ash. (c) Plane-polarized transmitted light photomicrograph of thin section showing detail of the paste. The red, light blue and green arrows indicate alite, belite and fly ash, respectively. (d) Cross-polarized transmitted light photomicrograph of thin section with gypsum plate inserted showing detail of the paste; the white arrows indicate calcium hydroxide.

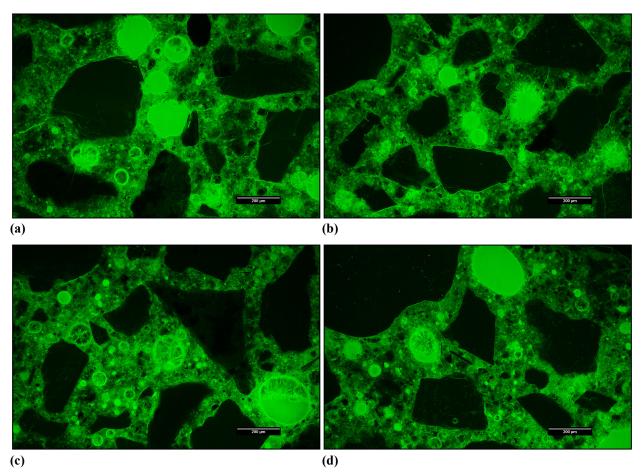
Figure 6. (a), (b) Transmitted fluorescent light photomicrographs of thin section from the Sample 2 showing detail of paste. (c), (d) Transmitted fluorescent light photomicrographs of thin section from Sample 5 showing detail of paste. The green tone of the images is a function of the infiltration of the fluorescent epoxy, such that it is proportional to the capillary porosity of the material. The black areas correspond to aggregate that has very low porosity or effectively zero porosity and the bright circular areas represent voids that are 100% porosity. The variations in green between aggregate particles reflect variations in the capillary porosity or micro-density of the paste. Note ettringite in voids in the images.

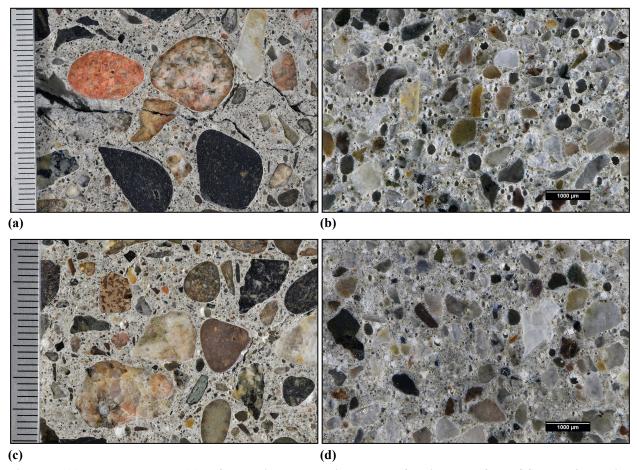
- 3.4 Components: Aggregates The coarse aggregate is a crushed gravel with a nominal top size of 25 mm (1 in.) in Sample 2 and 19 mm (1 in.) in Sample 5, respectively (Figure 7). The gradation and distribution are relatively even in both cores. The aggregate is siliceous in composition and consists primarily of rhyolite, granitic rocks, quartzite and chert with trace amounts of andesite and basalt. The fine aggregate is a natural sand that consists mostly of siliceous rocks similar to that observe in coarse aggregate. Both cores show evidence of severe ASR that involves rhyolite, chert, quartzite and andesite in coarse aggregate commonly but also occasionally in the fines.

Figure 7. (a) Photograph and (b) reflected light photomicrograph of polished surface of Sample 2 showing coarse and fine aggregate, respectively. (c) Photograph and (d) reflected light photomicrograph of polished surface of Sample 5 showing coarse and fine aggregate, respectively. The scale is in millimeters in (a) & (c).

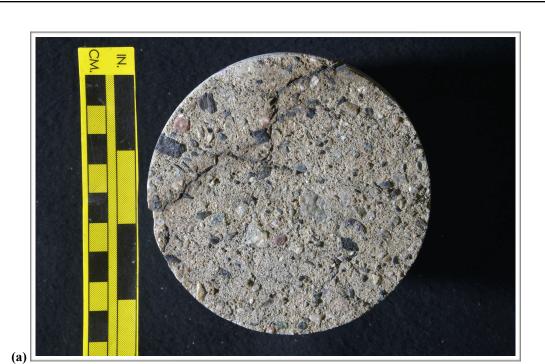
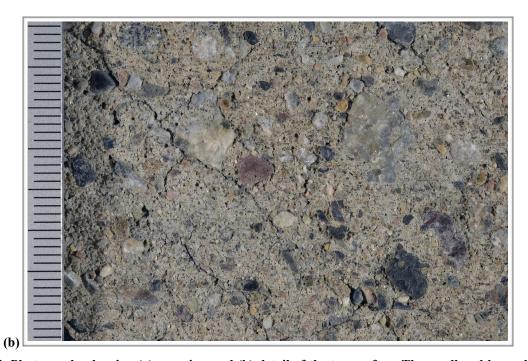
I. RECEIVED CONDITION	
Orientation & Dimensions	
Surfaces	The top surface is worn and expose coarse aggregate particles (Figure A3) and the bottom surface is a fracture such that the core represents a partial thickness of the bridge deck.
General Condition	The concrete is hard and compact and rings lightly when sounded with a hammer. A sub-horizontal crack ~ 120 mm (4 3 /4 in.) below the top surface cuts the core into two pieces. Because the crack is open the original width cannot be measured. White deposits of ASR gel were observed lining voids and coarse aggregate particles on the fracture surface and the bottom surface (Figure A4).

Figure A3. Photographs showing (a) overview and (b) detail of the top surface. The small and large divisions on the yellow scale in (a) are in centimeters and inches, respectively. The scale in (b) is in millimeters.

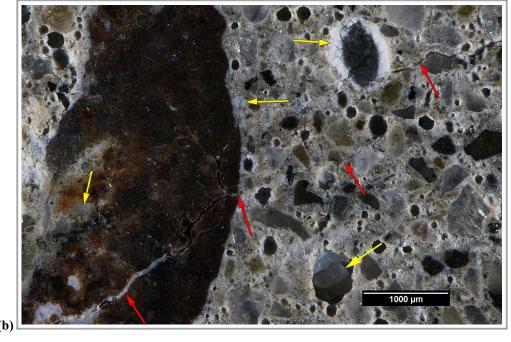
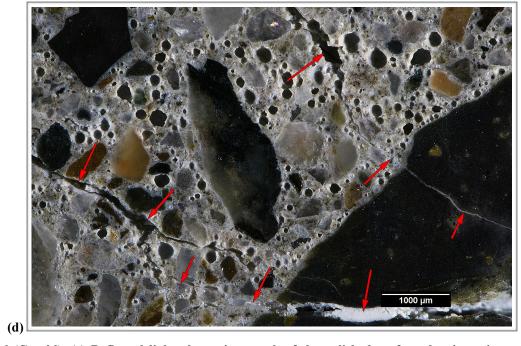
Figure A6. (a) Reflected light photomicrograph of the polished surface showing microcracks (red arrows) cutting through a rhyolite particle and filled with ASR gel. The yellow arrow in (a) indicates ASR gel lining a void. (b) Reflected light photomicrograph of the polished surface showing microcracks (red arrows) cutting through a rhyolite particle and filled with ASR gel. The yellow arrows in (a) indicates ASR gel lining voids and within the rhyolite particle.

Figure A6 (Cont'd). (c) Reflected light photomicrograph of the polished surface showing microcracks (red arrows) cutting through a quartzite particle. (d) Reflected light photomicrograph of the polished surface showing microcracks (red arrows) cutting through an andesite particle and filled with ASR gel.

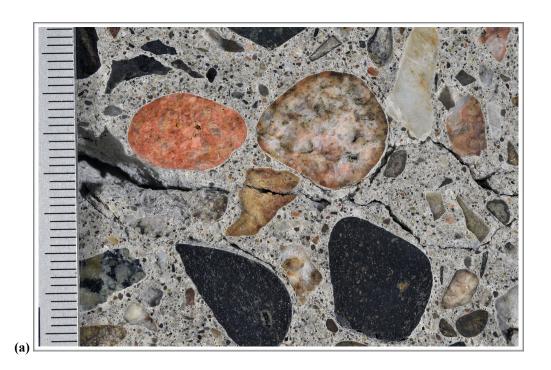
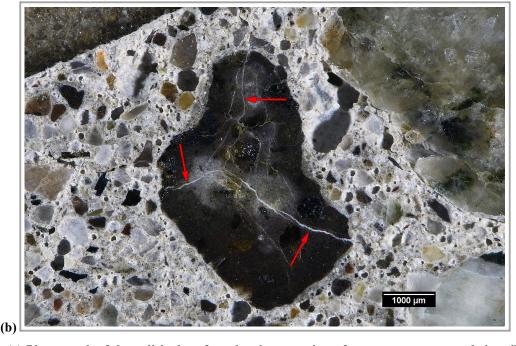
Figure A8. (a) Photograph of the polished surface showing overview of coarse aggregate; scale in millimeters. (b) Reflected light photomicrograph of the polished surface showing overview of a reacted andesite particle with internal microcracks filled with ASR gel (red arrows).

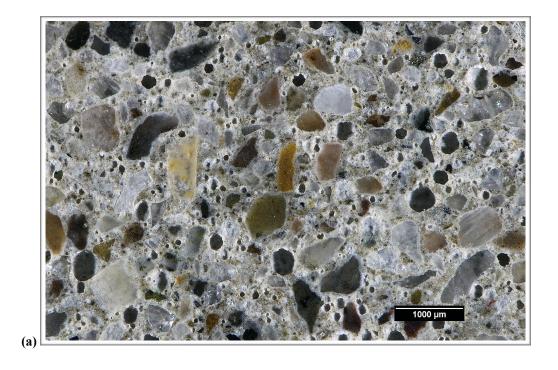
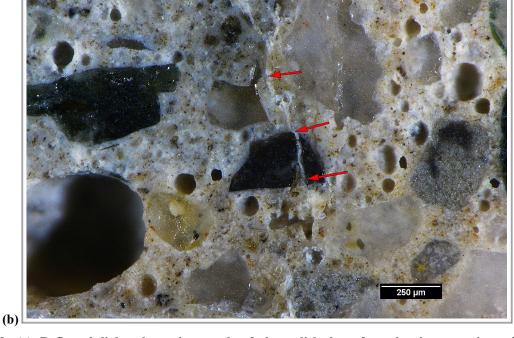
Figure A9. (a) Reflected light photomicrograph of the polished surface showing overview of the fine aggregate. (b) Reflected light photomicrograph of the polished surface showing overview of an andesite particle with microcracking (red arrows) with ASR gel cutting through it.

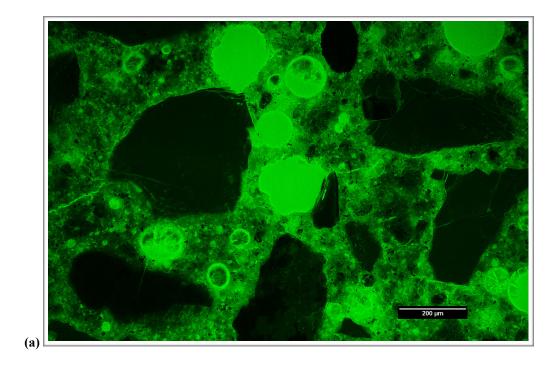
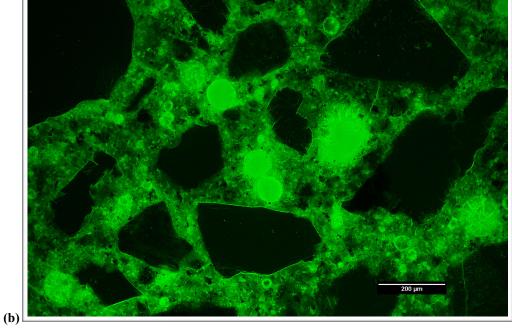
Figure A13. Transmitted fluorescent light photomicrographs of thin section showing detail of the capillary porosity of the paste. The black areas correspond to aggregate that has very low porosity and the bright green circles are air voids filled with epoxy. The variations in green between these end members reflect variations in the capillary porosity or micro-density of the paste. Note ettringite in voids.

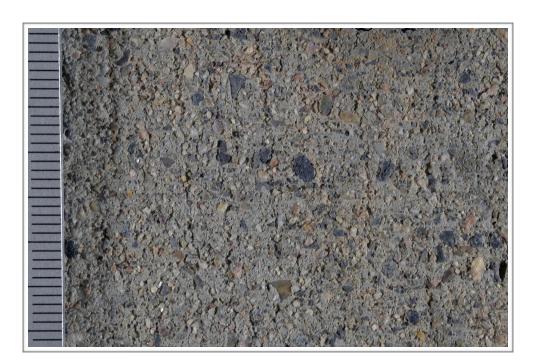
I. RECEIVED CONDITION	
Orientation & Dimensions	105 (C1/ 55/:)1 (Fi D4 Fi D6)
Surfaces	The top surface is worn and show fine aggregate particle (Figure B3) and the bottom surface is a fracture such that the core represents a partial thickness of the bridge deck.
General Condition	The concrete is hard and compact and rings lightly when sounded with a hammer. A sub-horizontal crack $60 - 90$ mm ($2\frac{3}{8} - 3\frac{1}{2}$ in.) below the top surface cuts the core into two pieces. Because the crack is open the original width cannot be measured. White deposits of ASR gel were observed lining voids and coarse aggregate particles on the bottom surface (Figure B4).

Figure B3. Photograph showing detail of the top surface; scale in millimeters.

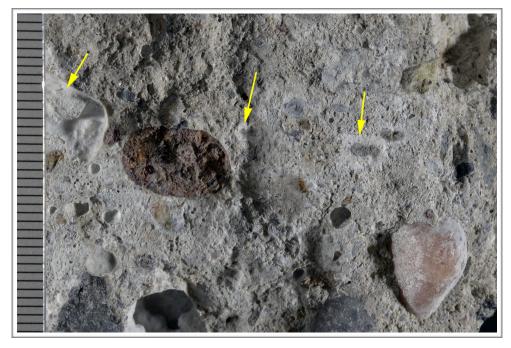
Figure B4. Photograph showing detail of ASR gel (yellow arrows) on the bottom surface of the core; scale in millimeters.

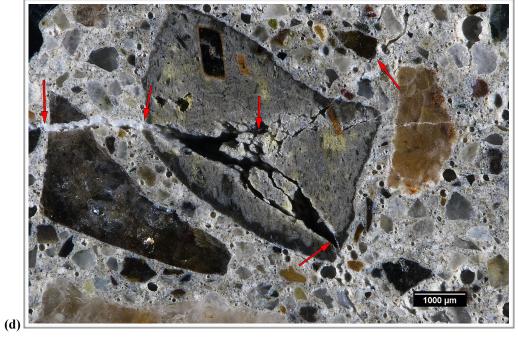
Figure B6 (Cont'd). (c) Reflected light photomicrograph of the polished surface showing microcracks (red arrows) cutting through a rhyolite particle. The green arrows in (c) indicate ettringite. (d) Reflected light photomicrograph of the polished surface showing microcracks (red arrows) radiating from a rhyolite particle and filled with ASR gel.

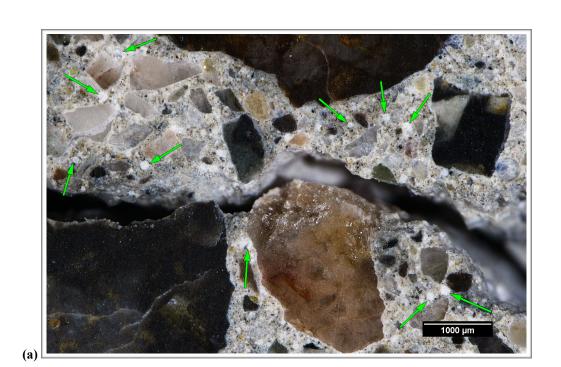
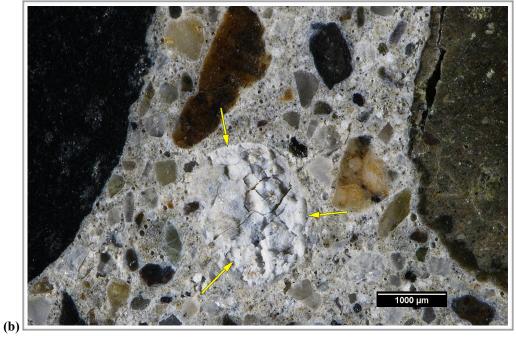
Figure B7. Oblique reflected light photomicrographs of the polished surface showing air voids filled with (a) ettringite (green arrows) and (b) ASR gel (yellow arrows) in the middle of the core.

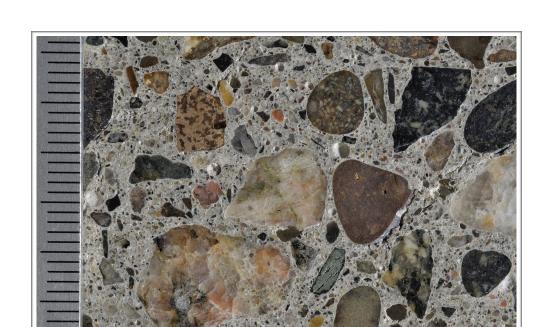
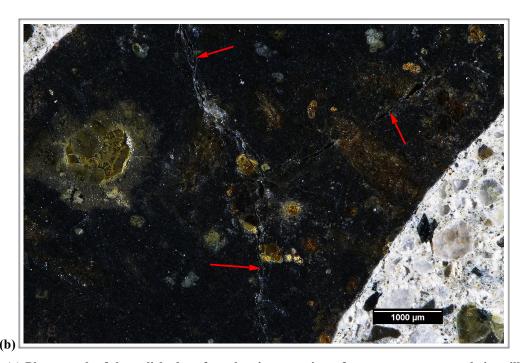
5. Coarse Aggregate	
Physical Properties	The coarse aggregate is a crushed gravel that has a 19 mm (¾ in.) nominal top size (Figure B8). The rocks are hard and competent. The particles are sub-equant to slightly elongated with aspect ratios of 2:1. The particles have sub-angular to sub-rounded edges.
ROCK TYPES	The aggregate is siliceous in composition and consist primarily of rhyolite with abundant phenocrysts of plagioclase and amphibole, granitic rocks, quartzite and chert. Minor amounts of andesite with abundant phenocrysts of amphibole and basalt were also observed. Abundant chlorite from hydrothermal alteration is present in rhyolite and granitic rocks. Rhyolite, granitic rocks, quartzite, chert and andesite are potentially susceptible to alkali-silica reaction (ASR).
Other Features	occasionally to commonly observed. Coarse aggregate particles occasionally show de-l

Figure B8. (a) Photograph of the polished surface showing overview of coarse aggregate; scale in millimeters. (b) Reflected light photomicrograph of the polished surface showing overview of a reacted andesite particle with internal microcracks (red arrows).

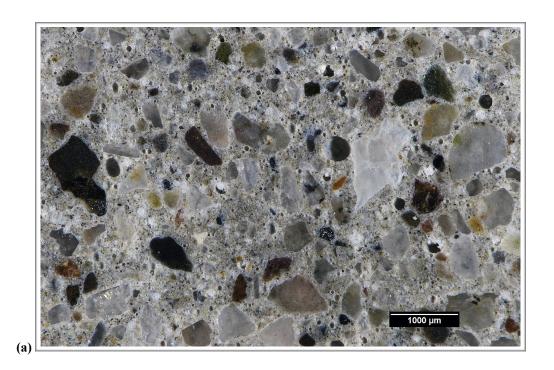
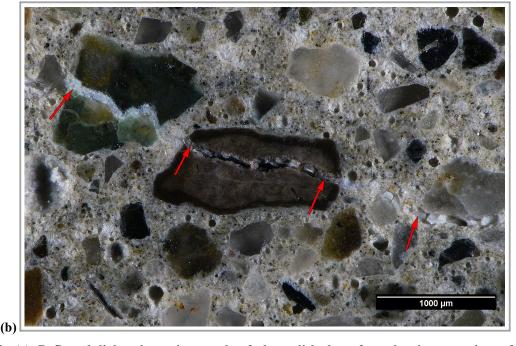
6. FINE AGGREGATE	
Physical Properties	By) The particles are mostly slip-edilant to slightly elongated in shape with slip-rollnded to l
ROCK TYPES	The sand consists of siliceous rocks similar to that observed in coarse aggregate. The fines also contain fragments of quartz and chlorite. Rhyolite, granitic rocks, quartzite, chert and andesite are potentially susceptible to alkali-silica reaction (ASR).
Other Features	No deleterious coatings or incrustations observed. Internal microcracking and reaction rims were occasionally observed. Deposits of ASR were occasionally observed lining the microcracks and voids associated with fine aggregate particles.

Figure B9. (a) Reflected light photomicrograph of the polished surface showing overview of the fine aggregate. (b) Reflected light photomicrograph of the polished surface showing overview of a rhyolite particle with microcracking (red arrows) with ASR gel cutting through it.

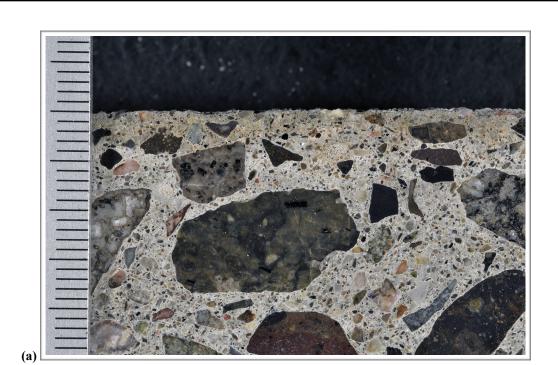
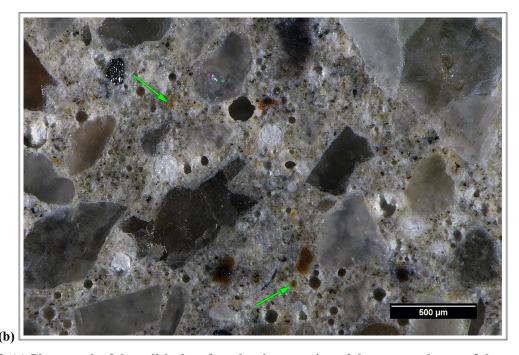
Figure B10. (a) Photograph of the polished surface showing overview of the paste at the top of the core.; scale in millimeters. (b) Reflected light photomicrograph of the polished surface showing detail of the paste in the middle of the core. The green arrows indicate fly ash.

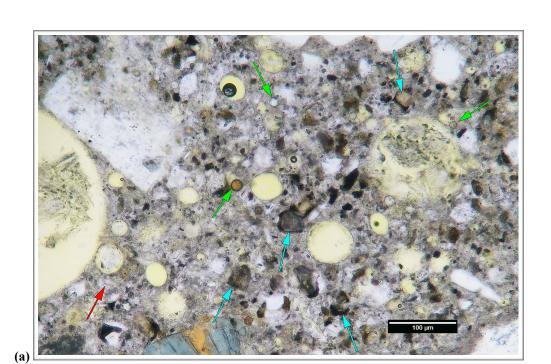
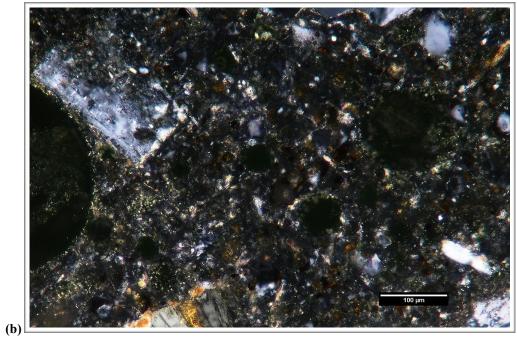
Figure B12. Transmitted light photomicrographs of thin section showing detail of paste in (a) plane-polarized and (b) cross-polarized light. In (a) the red, blue and green arrows indicate alite, belite and fly ash, respectively.

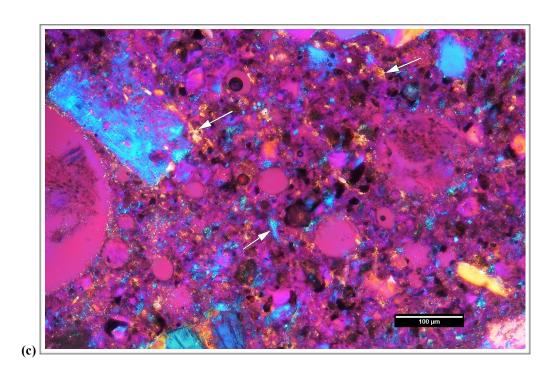
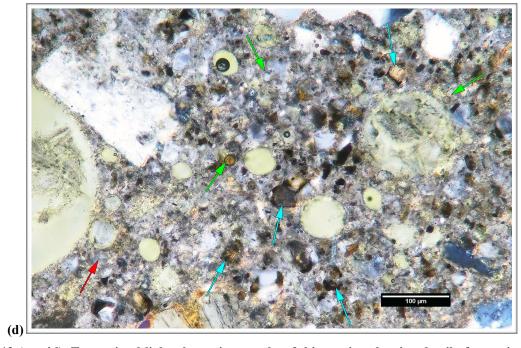
Figure B12 (cont'd). Transmitted light photomicrographs of thin section showing detail of paste in (c) cross-polarized light with the gypsum plate inserted and (d) cross-polarized light with the quarter wavelength plate inserted. The white arrows in (c) indicate calcium hydroxide. In (d) the red, blue and green arrows indicate alite, belite and fly ash, respectively.

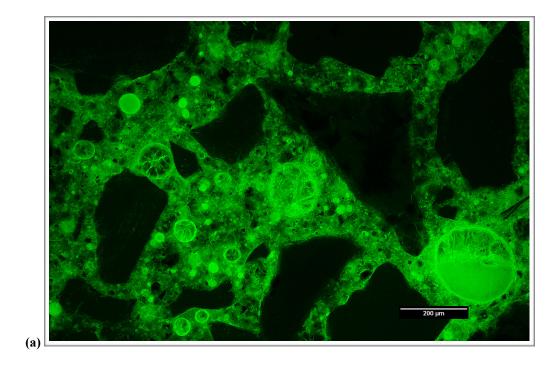
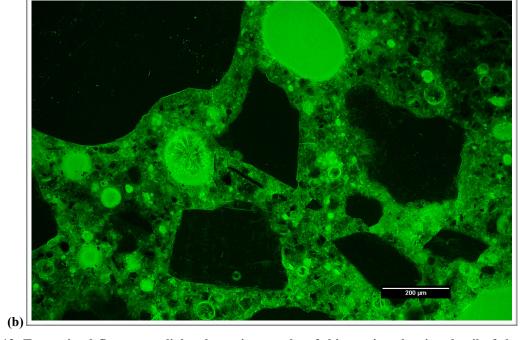
Figure B13. Transmitted fluorescent light photomicrographs of thin section showing detail of the capillary porosity of the paste. The black areas correspond to aggregate that has very low porosity and the bright green circles are air voids filled with epoxy. The variations in green between these end members reflect variations in the capillary porosity or micro-density of the paste. Note ettringite in voids.

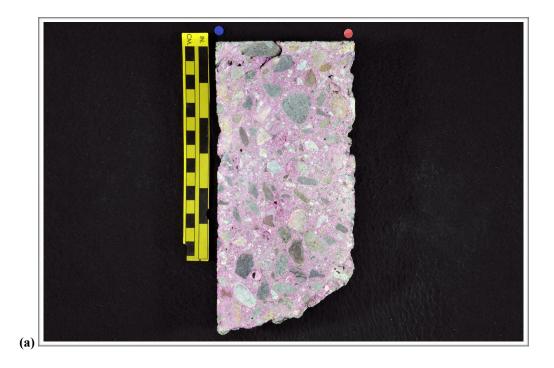
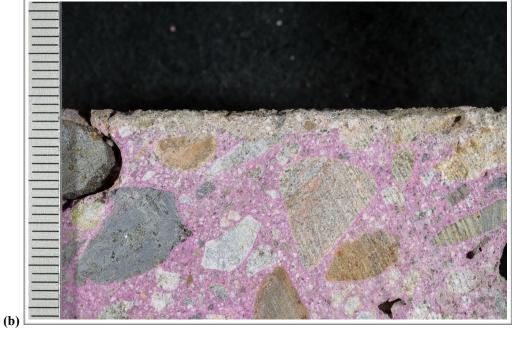
8. Secondary Deposits	
PHENOLPHTHALEIN	Entire surface stains purple except for light purple staining in top ~ 2 mm (80 mil) of the core (Figure B14).
Secondary Deposits	Carbonation was observed in top ~ 2 mm (80 mil) of the core. Deposits of gel were occasionally to commonly observed in voids and cracking/microcracking throughout the entire depth of the core. Deposits of ettringite were observed commonly in voids throughout the entire depth of the core. ASR Rating: Severe ASR.

Figure B14. Photographs showing (a) overview of phenolphthalein-stained surface and (b) detail of surface near the top of the core. The yellow scale in (a) is \sim 150 mm (6 in.) long; the small and large divisions are in centimeters and inches, respectively. The scale in (b) is in millimeters.
